# Barrier Replacement Works of the Ruitelán Viaduct A-6 P.K. 424 + 000

## *Obras de sustitución de pretil del viaducto de Ruitelán A-6 P.K. 424+000*

Jorge Alberto Cerezo Macías<sup>a</sup>, Elena Seguido Fernández-Tresguerres<sup>b</sup>

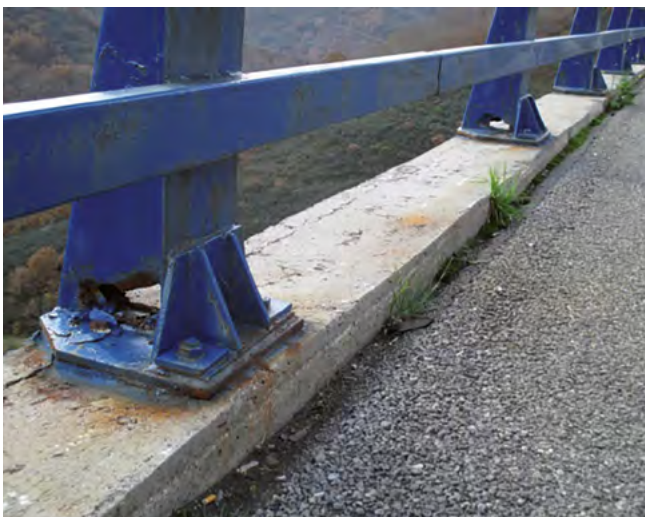
On each of these occasions, a survey of pathologies of the various elements of the bridge was carried out and it was concluded that, at the beginning, the damage did not require an immediate intervention. However, during these inspections, damages were already located in some of the parapets (figure 4).

Figure 4. Detail of deterioration in parapets.

Over the time, the parapets have suffered an increase of their deterioration, basically caused by the aggressive environment in which they are located.

The Ruitelán Viaduct is located in an area of the highway, with very low temperatures during the winter season, which requires the use of de-icing salts on the road, to ensure the flow of traffic through this important connection between Madrid and Galicia (winter roads).

These salts are a source of damage and deterioration for the metallic elements, such as the existing parapets, and for the concrete ones, such as the anchorage band of the parapets,

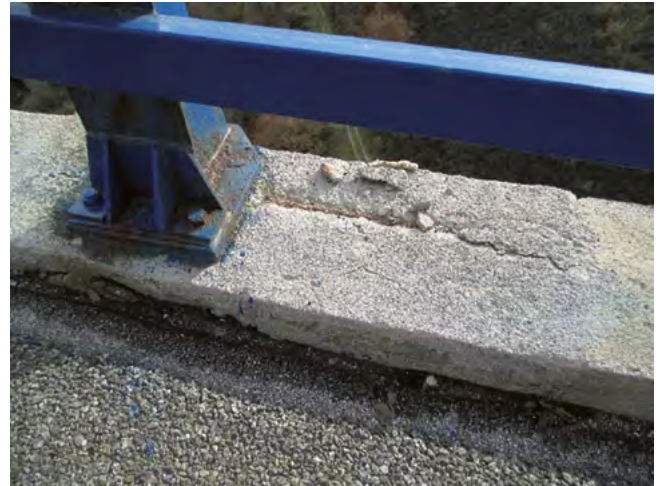
Besides, already at that time, other deteriorations were registered in the concrete of the bands where the parapets are anchored (figure 5).

Figure 5. Detail of strapping damages.

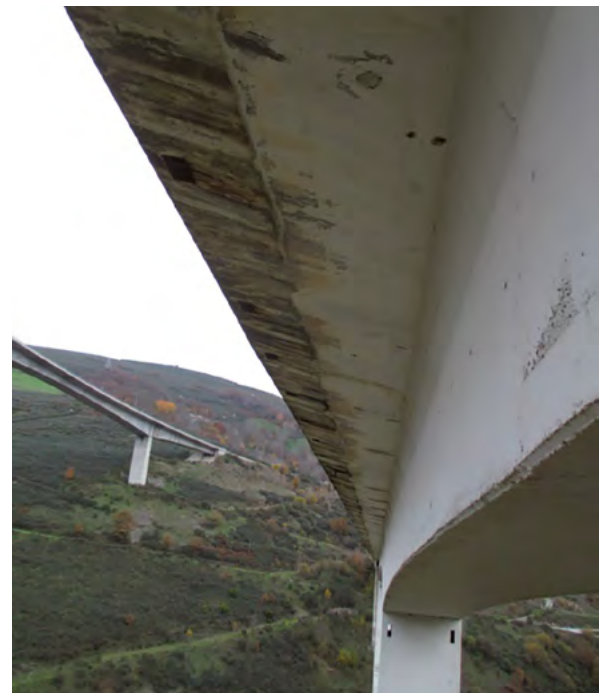
On the other hand, in these inspections it was possible to verify a certain deterioration in the area of the cantilevers of the deck, where the original structure joins the expansion of the deck carried out later (figure 6).

Figure 6. Cantilever status view.

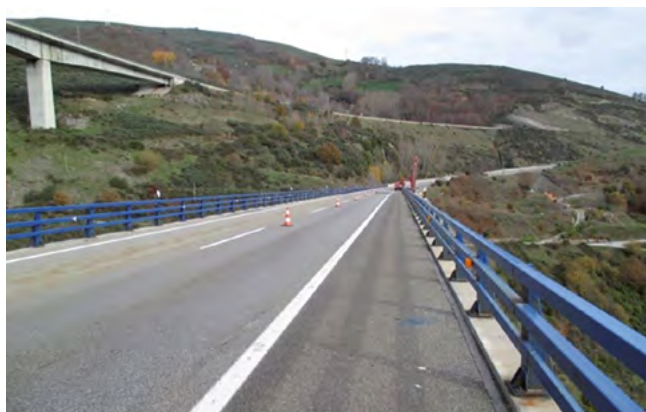
In a last inspection carried out in October 2015, it was found that the deterioration of the parapet on the right edge of the Viaduct (corrosion, both in the barrier's posts and in its anchorages) affected just over 50% of the total length of the parapets on that side of the structure (figure 7), and due to these circumstances, the Ministry of Public Works (Ministerio de Fomento) has taken action, through emergency work, to restore the adequate conditions of the containment system.

Figure 7. View of the state of the parapet (2015).

The general condition of the parapet, as well as the precarious state of conservation of some of its parts, have led to the need of an emergency intervention, in order to carry out the replacement works of the parapet in the short term, to re-establish appropriate conditions of the containment system in the viaduct.

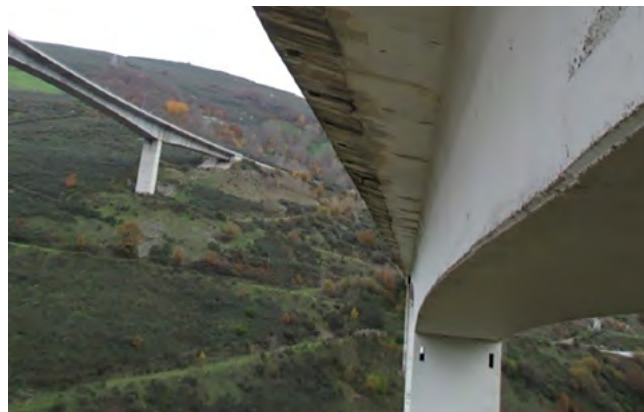
In the particular case of this viaduct, due to the state of deterioration related to the edge area of the previously extended deck (figure 8), it has been considered necessary to extend the reconstruction of the deck to a larger area than that strictly necessary for the installation of the new CE-marked parapet.

Figure 8. View of the state of the right edge of the existing extended deck.

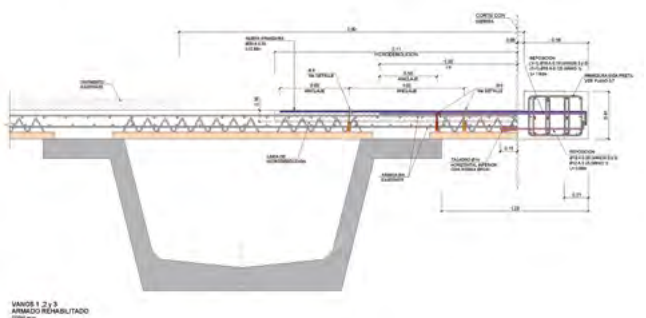
Figure 13. Section type performances spans 1 to 3.

The most important particularization is the definition of the area to be hydrodemolished. In the case of the standard section of spans 1 to 3, the width was 2.11 m, and its depth was 0.10 m (figure 13).

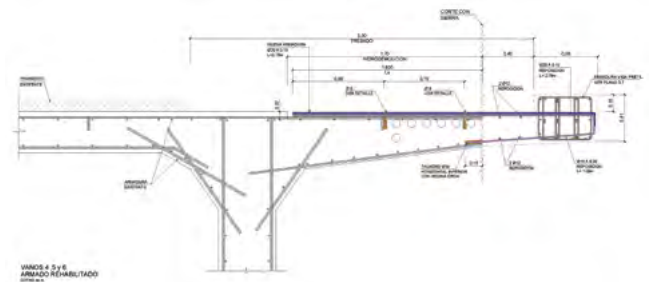
Figure 14. Section type performances spans 4 to 6.

In the standard section of spans 4 to 6, the width was 1.70 m, and its depth was 0.07 m (figure 14). The real depth was variable, since the different qualities of the concrete to be demolished and the existence of the sheaths near the hydrodemolition zone, did not allow to adjust to the theoretical level foreseen.

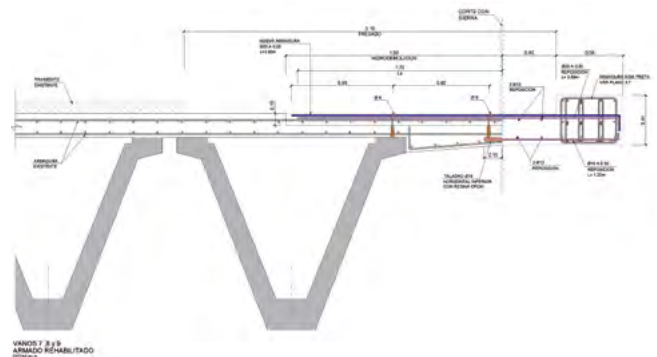
Figure 15. Section type performances spans 6 to 9.

Finally, in the case of the standard section of spans 7 to 9, the width was 1.80 m, and its depth was 0.10 m (figure 15).

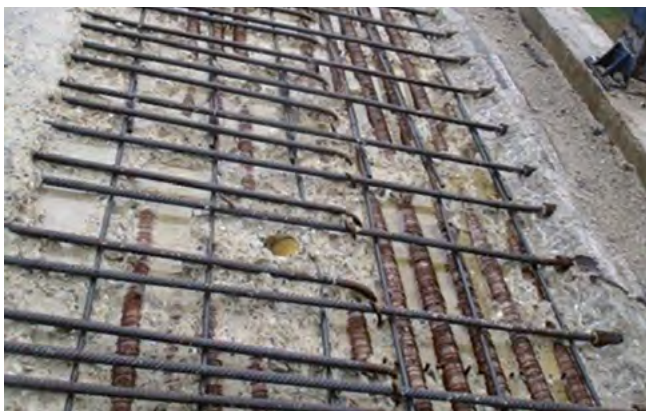
Figure 24. Existing and exposed post-tensioned sheaths.

It should be noted that, in the spans built by balanced cantilevers, hydrodemolition left several post-tensioning sheaths visible (figure 24), some of them with certain deterioration (figure 25 and figure 26) which, although they did not affect the cables, were repaired by means of sealing injections, improving the durability of the work by protecting the cables contained in them.

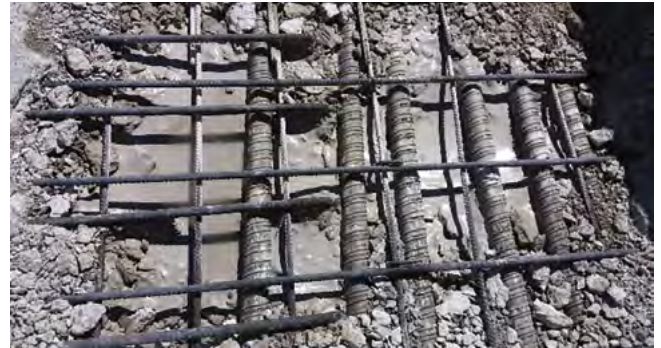
Figure 25. Post-tensioned sheath details with deterioration.

The mentioned damages in certain sheaths were originated by a defect in their filling, concretely the lack of grout in some areas, which caused that when carrying out the hydrodemolition of these sheaths, they were deteriorated and allowed to visualize their lack of filling.

These deteriorations were repaired by cleaning the affected areas, both the sheaths themselves and the cables that had been seen, by manually brushing these elements, and then injecting grout.

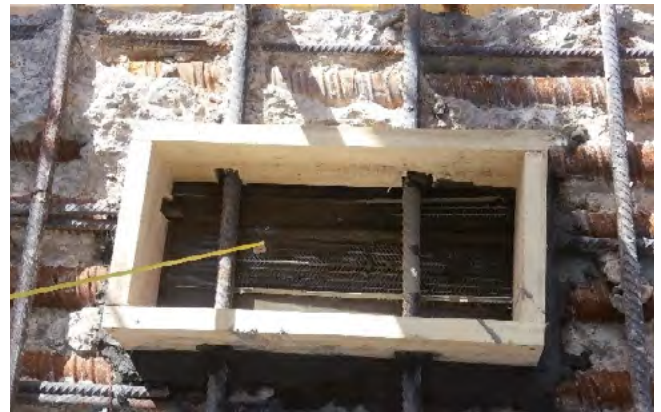
Figure 26. Deteriorated sheath sealing boxes.

To confine the area to be injected, wooden boxes were assembled and sealed around the perimeter with repair mortar (figure 26); a ribbed metal sheet was then laid out to ensure roughness between this paste and the concrete to be placed in the rest of the span. Finally, a sheet of plywood was placed between the sheaths and the passive reinforcements that cross over them, to close the area to be injected and to be able to perform a correct injection of the holes in the sheaths.

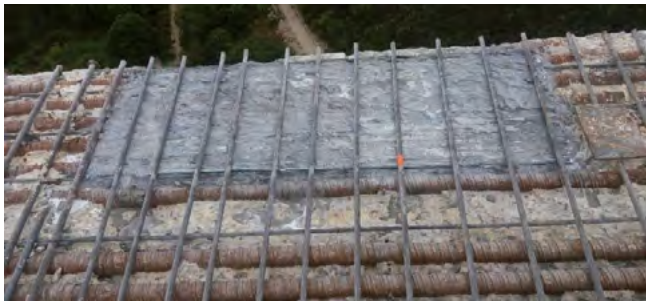
Figure 27. Sealing of deteriorated sheath areas.
