Progreso's viaduct in Yucatan, Mexico: First durable concrete structure in the world made with stainless steel

Andrés A. Torres-Acosta^{a,*}, Miguel Martínez-Madrid^b, Pedro Castro-Borges^c

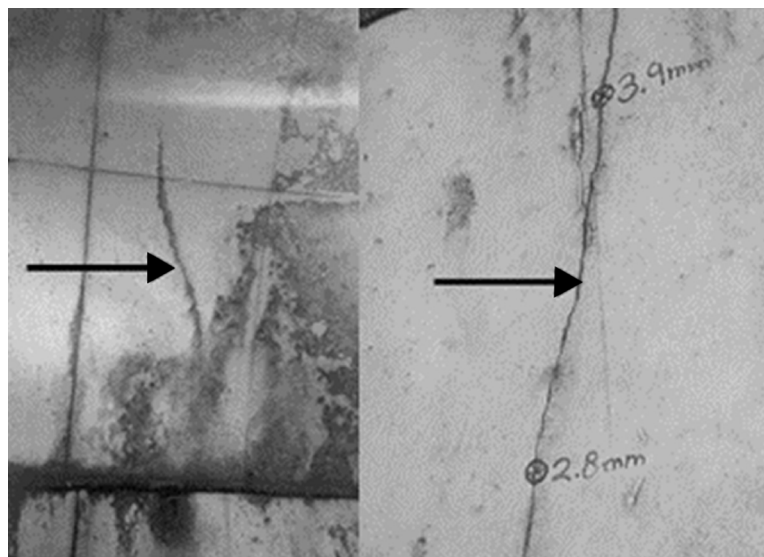
Other results obtained during the continuous evaluation plan, performed by this group, included a detailed crack survey from some of the arches of the viaduct (its pattern is similar to the observed in Fig. 3). This crack intensification has warned API

Figure 3. Typical structural cracks observed on the unreinforced concrete arches.

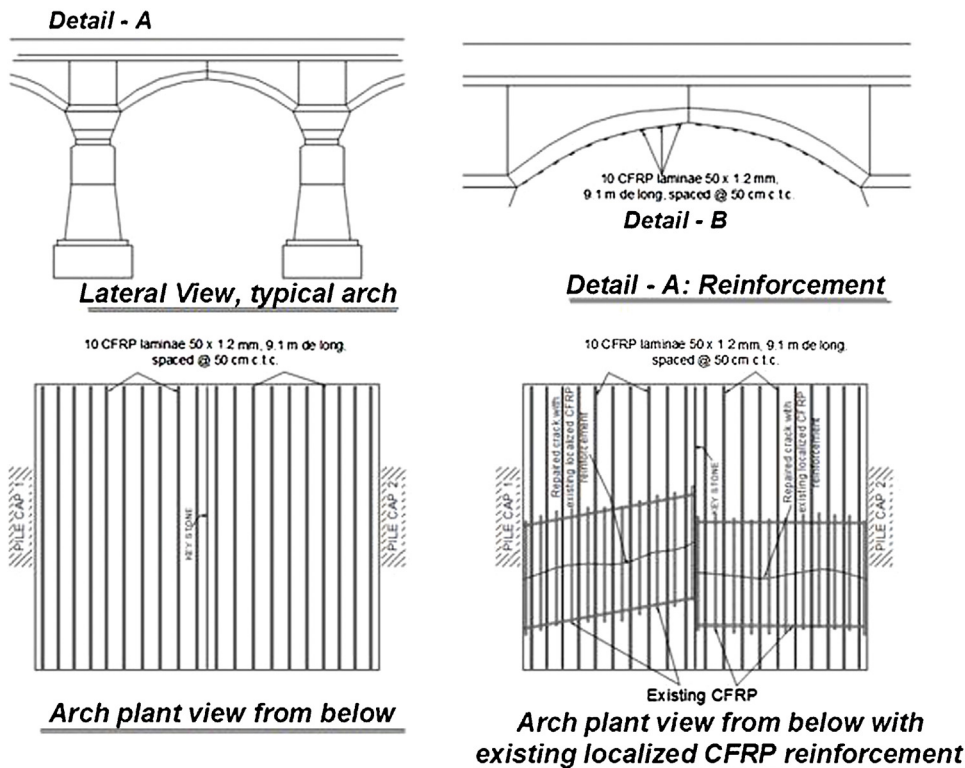
During a routine inspection in 2007, more arches presents structural cracks, therefore a second rehabilitation work was performed using similar CFRP strips during 2008. However, during this rehabilitation work, additional cracks were observed on the already repaired arches using the localized procedure: CFRP strips glued just in the crack length (Fig. 5). Thus, the procedure of externally reinforced the cracked arches using CFRP strips was changed from localized reinforcement (just placing CFP on top of cracks) to a general reinforcement placing CFP strips on all the width of the arches. In 2009 API obtained additional economical resources to reinforce all the 145 arches of the old viaduct, finishing this work at the end of 2009.

Figure 5. CFRP reinforcement of the cracked arches at the entire arch width. (a) Arch without previous reinforcement, (b) arch previously reinforced with localized CFRP strips.
