Membrane Substitution of La Cartuja Stadium Roof in Seville, Spain

Enrique Goberna Pérez^a, Knut Stockhusen^b, Mike Schlaich^c

KEYWORDS: Large span roof, lightweight structures, membrane, pathology of structures, steel, cables.

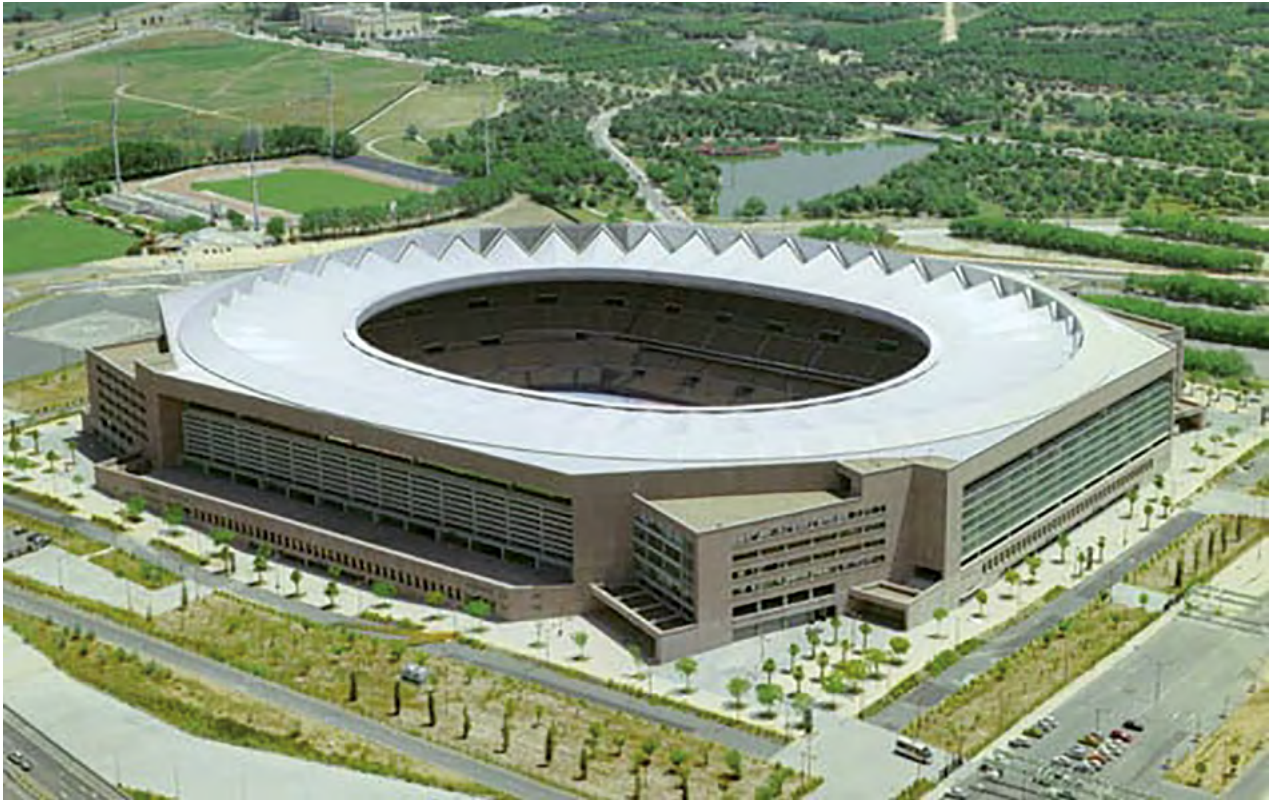
Figure 1. Olympic Stadium “La Cartuja” in Seville. Credit: La Cartuja Stadium SA.

In this paper, the project for the refurbishment of the large span roof with structural membrane of Estadio de La Cartuja in Seville (figure 1), Spain, is described. Its aim is to go through

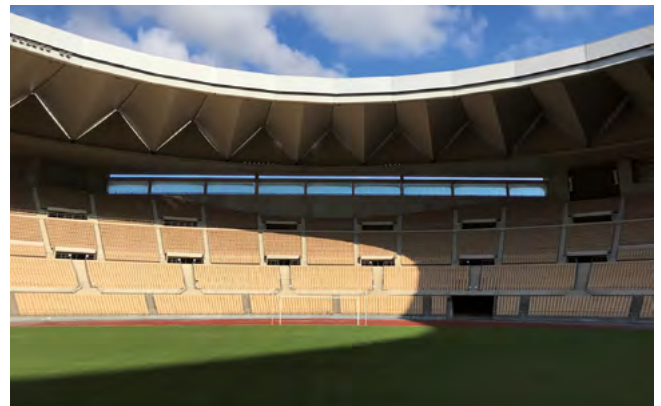
La Cartuja Stadium is a multi-purpose stadium located in Isla de la Cartuja in Seville, Spain (figure 2).

Figure 2. La Cartuja Stadium, Inside view Credit: schlaich bergermann partner.

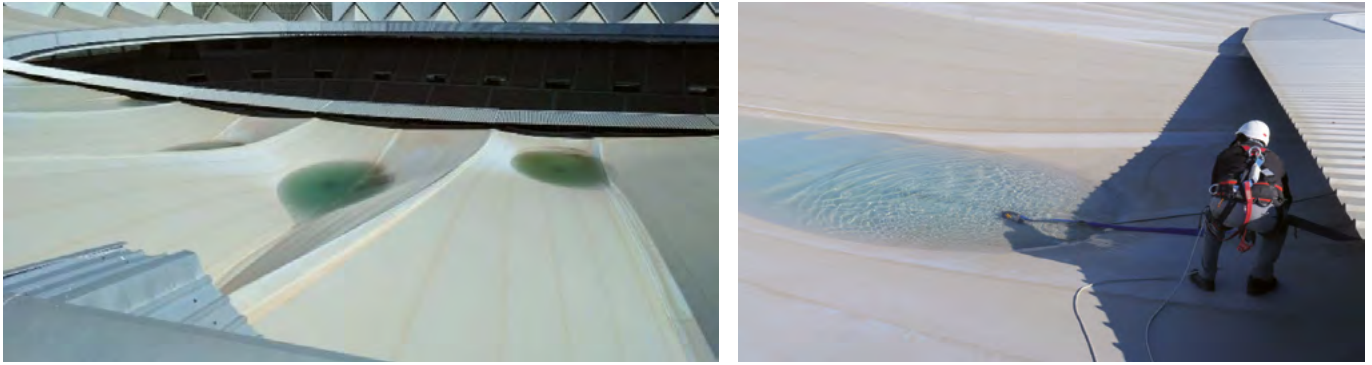
There were eight ponds located at the valleys of the five membrane panels on the west side of the roof (figure 5). The water ponds occurred at a variable distance between 3m and 10m from the tension ring, in any case, at the third of the span of the roof closest to the tension ring.

Figure 5. Ponding on the roof. Credit: schlaich bergemann partner

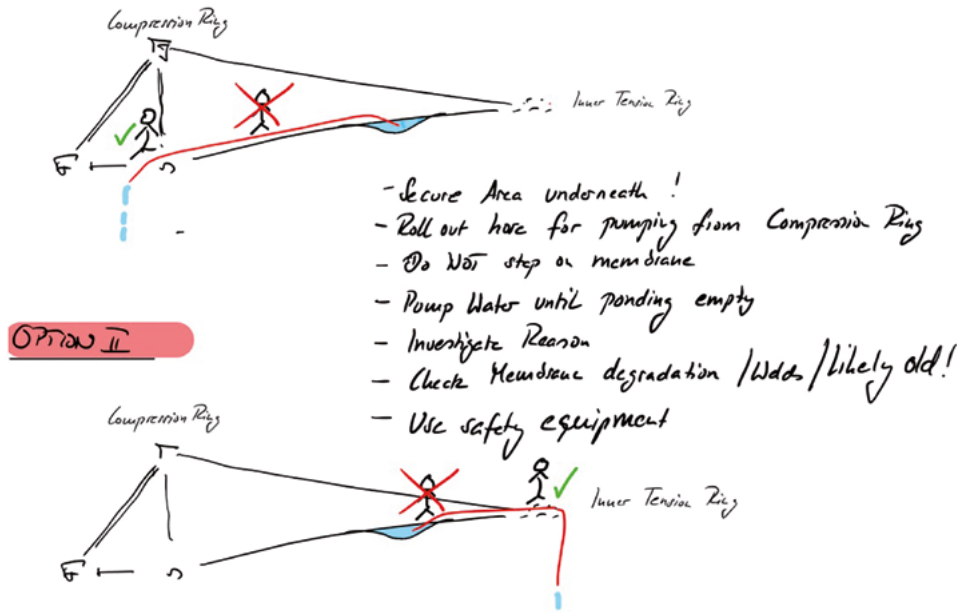
After the notification of the problem and the preliminary analysis of the photographs received, it was determined that the drainage problem would not compromise the global structural integrity of the roof, although it could lead to a local failure of the membrane. Therefore, a series of immediate measures to be carried out on the roof were communicated (figure 6), consisting of:

Figure 6. Immediate instructions given right after notification of the issue. Credit: schlaich bergemann partner.

1. To cordon off the west grandstand.
2. To install lifelines to secure the maintenance personnel on the roof with harnesses.

3. To pump the water out from the ponds with of conventional pumps.
4. Do not step on the membrane.

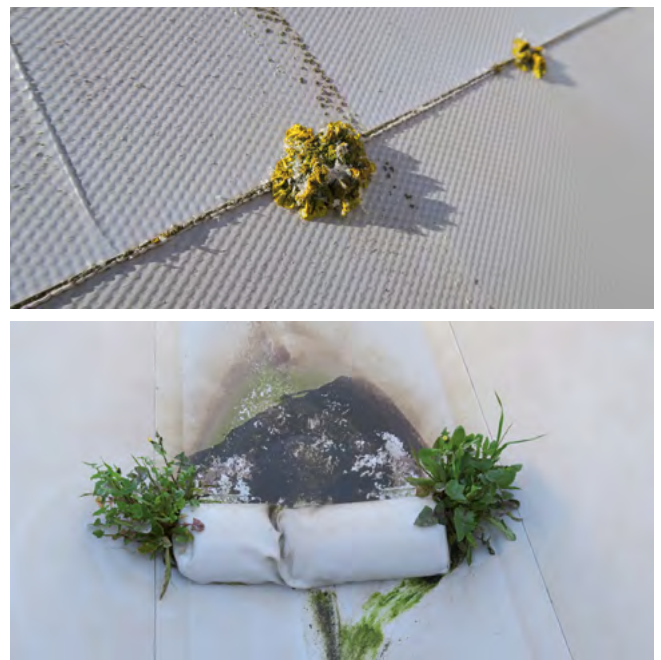
After 20 years of service, the roof was experiencing rainwater drainage problems. In order to determine the reasons as well as evaluate possible solutions a site visit was made. In this site visit, it was found that there was not much maintenance or inspection performed on the roof during its life span. This was evident in the accumulation of lichens and even vegetation in some points of the membranes (figure 7).

Figure 7. Some evidence in lack of maintenance. Credit: schlaich bergemann partner.

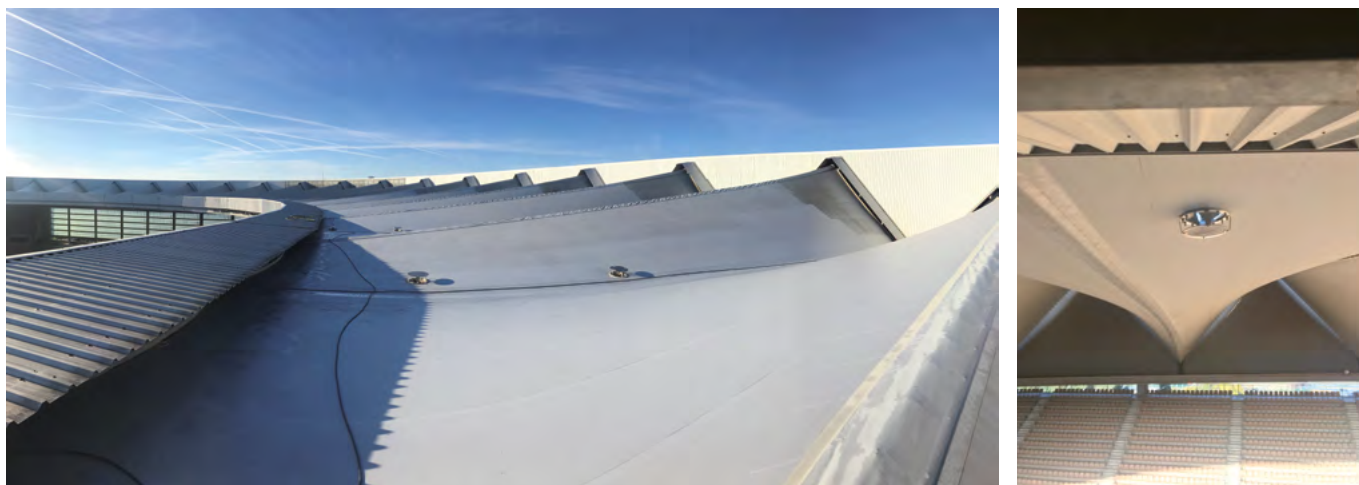
Figure 8. Drainages holes. Credit: schlaich bergemann partner.

However, it was also clear that the lack of maintenance on the membrane was not the main cause of the drainage problems with the roof. It was noted that the membrane had a clear lack of tension most probably due to aging effects. The topcoat of the membrane was coming off. It could be evidenced then that the life span of the membrane was close to its end. On the other hand, it was also noted that the points where ponding happened would become a focus for water accumulation as soon as it rained again. For this reason, it was necessary to drill some holes (figure 8) in the points that, *in situ*, were detected as those with the lowest relative level (more or less the center of the ponds: these were easy to identify since the accumulated water left a clearly distinguishable patch).

To make these drains while maintaining the integrity of the membrane, two stainless steel circular headplates were first screwed on and then a cross-cut in the center was made in the membrane. A diffuser plate was also installed to pre-

vent rainwater flowing down as a stream on rainy days. These drains, as a provisional solution, allowed, under certain conditions, the operativity of the stadium until a long term solution was found.

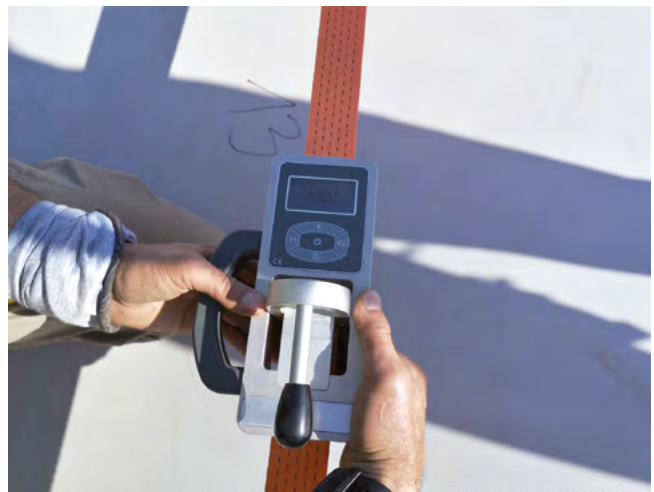
Figure 15. Ratched belts under 5kN tension every meter. Checking of the force. Credit: Pfeifer Seil- und Hebeteknik GmbH.

The next step was to install ratchet straps, tangentially joining the radial ridge cables with the valley cables on both sides (figure 15). The straps are distributed evenly in a radial direction over a distance of one meter. These belts are tight-

ened with a force of 5 kN each, thus trying to represent the tensional state of the future membrane that will replace the existing one.

The tensioning process of the belts had to be an iterative process since when manipulating a belt, the next ones would be misadjusted. After several iterations, it was possible to obtain the desired forces in the belts. Once the straps had the appropriate force, a topographical measurement of the geometry of the edge cables was made. This geometry was the basis for determining the geometry of the membrane in its permanent state, and thus proceed to the pattern of the membrane accordingly.

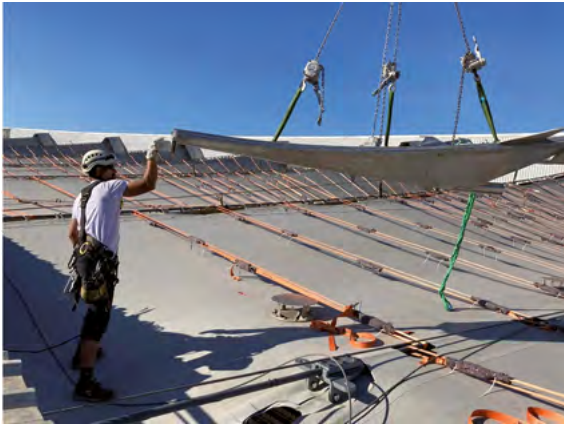
Figure 16. Radial drainage pipes and funnels at Tension Ring installation. Credit: Pfeifer Seil- und Hebeteknik GmbH.

The necessary holes for the installation of the funnels at the tension ring and at the compression ring were opened in the existing membrane. The radial drainage pipes at the two selected locations and the tangential pipes along the tangential catwalk were also installed (figure 16). The last step was the installation of the new membrane panels on the existing cables (figure 17). During the construction process the stadium was operational under certain limitations. For example, in late October and mid-November 2020, it hosted two UEFA matches behind closed doors due to pandemic restrictions.

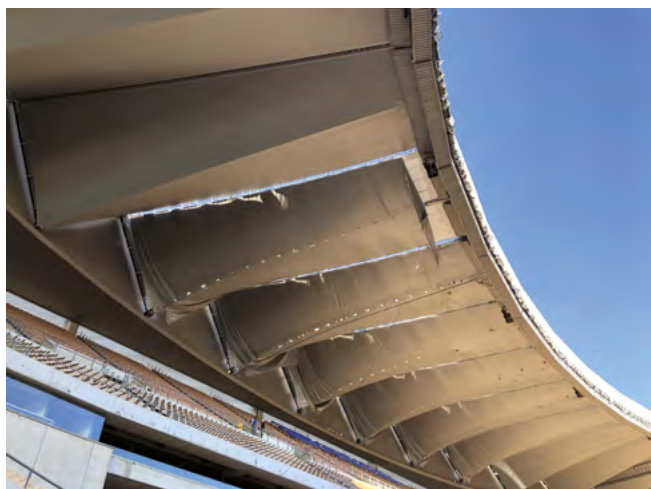
Figure 18. controlled detachment of the existing membrane after installation of membrane modules. Credit: schlaich bergemann partner.

The to-be-replaced membrane, which was practically stress free when the belts are tightened, remained installed at all times, acting as a safety net. It was eventually removed at the end of the whole process when the new membrane was fully installed. This simplified the process significantly.
