Replacement of the Deck and Rehabilitation of the Viaduct at the Link Between M 40 and M 607 in Madrid (Spain)

Juan Rodado, & Fátima Otero

Replacement of the deck and rehabilitation of the viaduct at the link between M-40 and M-607 in Madrid (Spain)

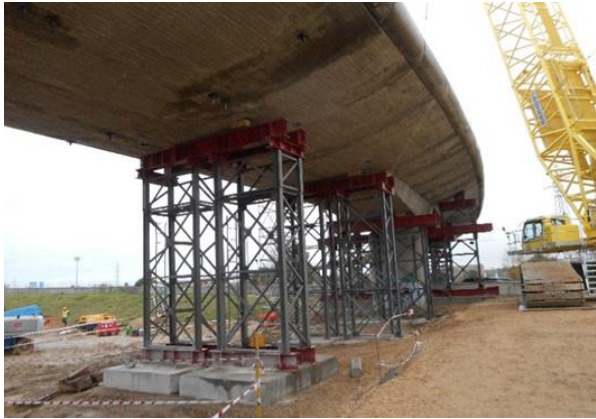
Figure 4. Temporary steel towers to support existing deck sections.

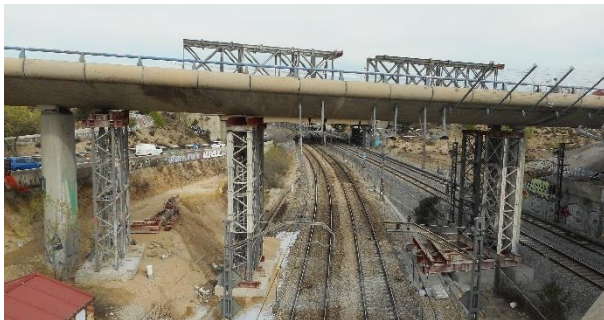
Figure 23. Phase 17: Disassembly of span 16 over railway line

At the spans over the railway lines between piers P15 and P16 and between P16 and abutment E2 (Figures 22 and 23), respectively, longest sections were needed, up to 14 m and 3414 kN, due to the presence of the railway lines, which required wider horizontal clearances between towers. For those sections additional cuts had to be performed to divide the sections into lighter parts by removing the ends of the section in first phase and then the central core in second phase (Figure 25). The three parts were tied together by means of a steel cross beam over the deck and prestressed bars (Figure 26). The sections on this area were cut and removed in close coordination with the railway administration to provide gaps without traffic of trains for these operations, always in night hours.

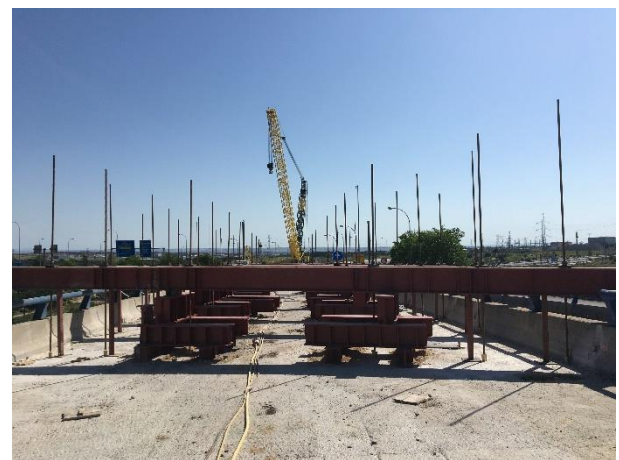
Figure 26. Auxiliary steel structure to tie deck cross section over railway lines

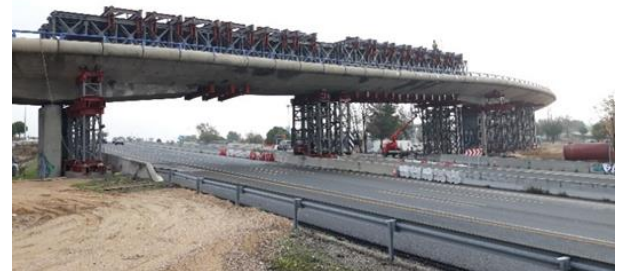
This alternative method had to ensure the safety during all operations with the traffic under the deck during certain phases. It was decided to place steel trusses over the deck spanning each carriageway of the M-40 ring road (Figure 27). These trusses were supported on the deck over the existing substructure and on temporary towers placed on the berms and on the central reserve (Figure 28).

Figure 28. Truss girders for auxiliary structure to dismantle main span over M-40

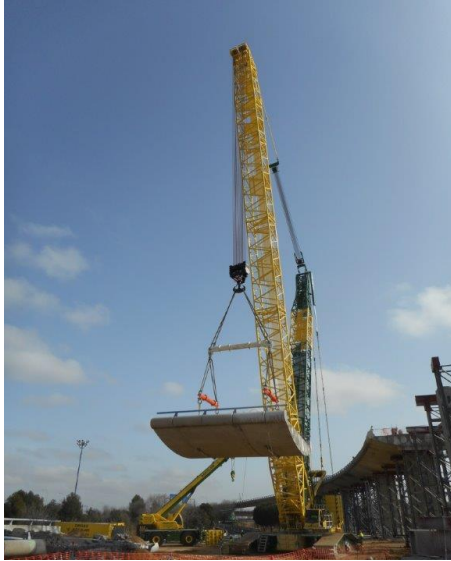
To conduct the disassembly of segments in the typical spans, a 5886 kN crawler crane was used (Figure 29), whose position was carefully studied to minimize the translation operations according to the working distances. A working performance of one segment per day was achieved in general in the disassembly process, including cutting and removing of segments.

Figure 29. High-capacity crawler crane during disassembly operations

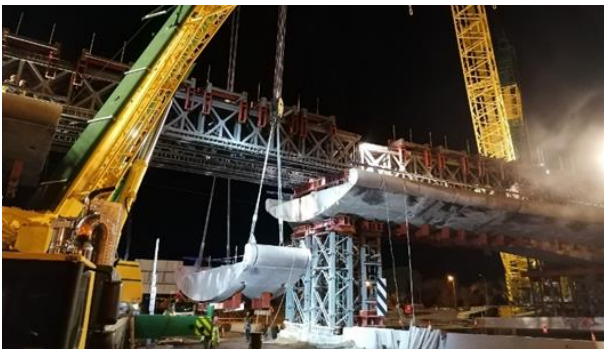
Once all the segments were cut and fully hanged from the trusses, they were taken by the cranes to be lowered in the vertical of their position. In this position each segment was left on a truck cage to be transported to the demolition area (Figure 30). The whole operation was conducted during the

Figure 30. Disassembly of the span over M-40 carriageways

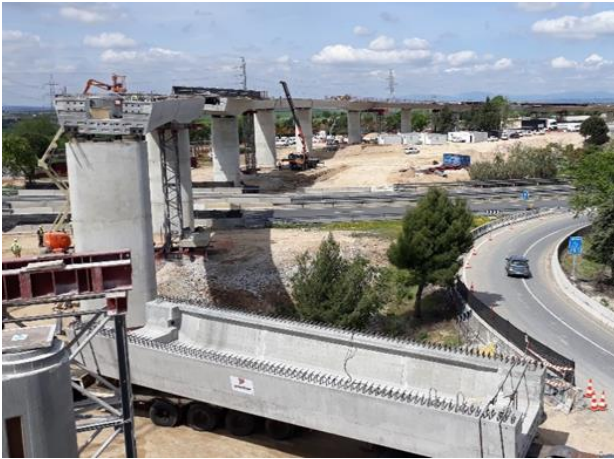
Figure 32. Precast beam before installation

All the precast concrete U beams were fabricated at Grupo Puentes factories of Prethor in Lugo (Spain) (Figure 32). The depth of the precast beams is, in general, constant of 1.70 m for most of the spans but it is increased linearly up to 2.55 m at the piers located close to the longest spans (piers P4, P5, P7, P10 and P11) (Figure 33). The length and weight of the beams is variable depending on their position along the deck and their depth. It is interesting to outline the following data:

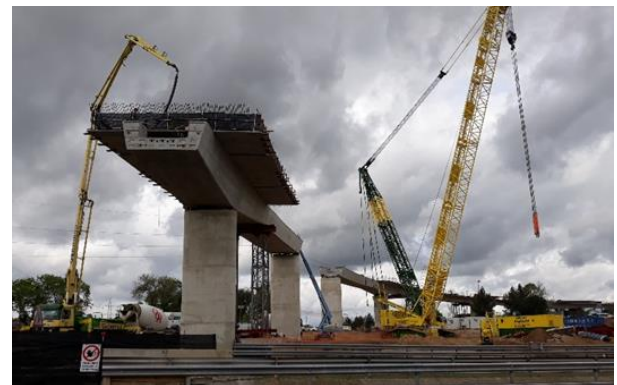
Due to the specificity of this kind of modular bridge and the necessity of minimizing the traffic cutting on the roads crossing under the viaduct, the erection process for the beams has been very carefully studied and executed, with full control of all the movements which has allowed to place the beams at their positions with very reduced tolerances to provide continuity to the deck.

Figure 33. Construction of new deck over M-607 carriageways

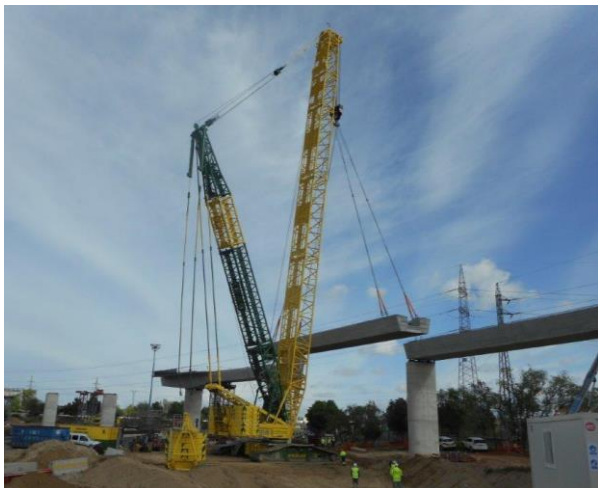
During this erection process auxiliary structures together with temporary bearings have been used to support some of the beams previously to the connections between them. Other beams have been temporary supported on the adjacent ones without temporary cantilever steel supporting structures. All the beams were placed in their definitive position by means of the same 5886 kN crawler crane used for the disassembly of deck segments (Figure 34).

Figure 34. Crawler crane during beams placement

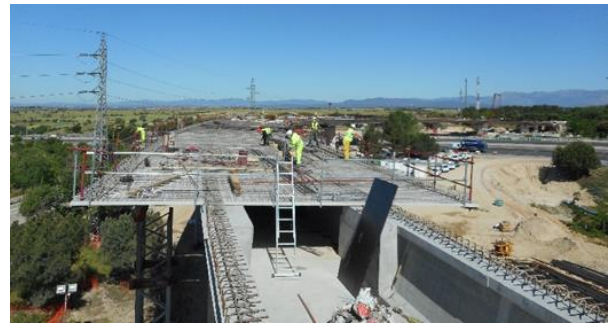
Figure 36. Construction of top slab by means of thin precast slabs over precast U beam

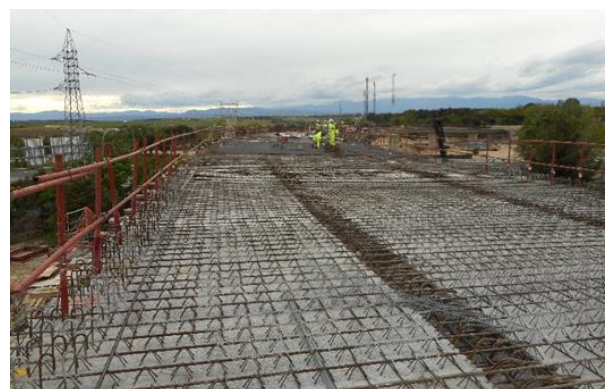
Figure 38. Top slab during reinforcing installation

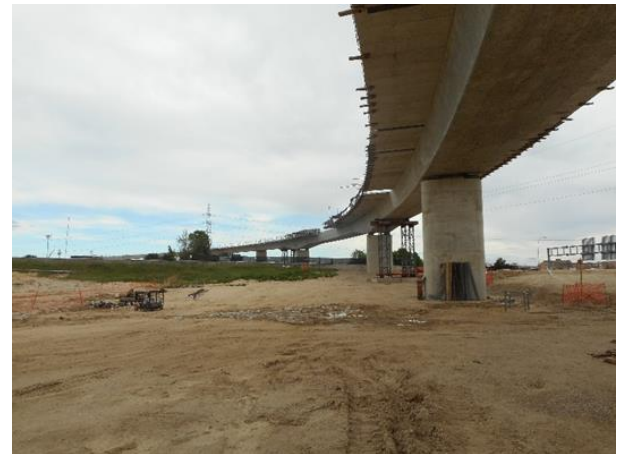
The object of this complex construction process is to guarantee that during its execution the forces induced at the beams sections and slabs are always under the values of resistance of those elements, which is governed by the service loads and conditions, together with the stability of all the precast elements during the construction process (Figure 46).

Figure 46. Bottom view of the new deck during construction

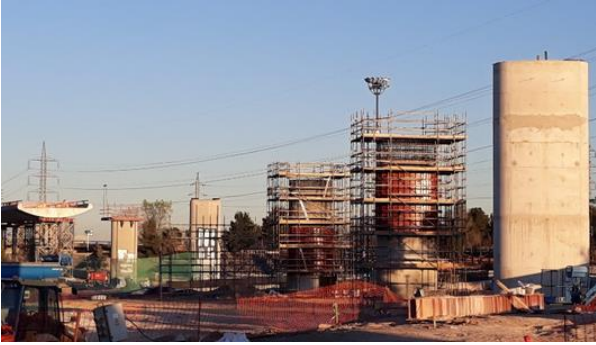
The analysis of the existing substructure, piers and foundations, lead to the conclusion that no deterioration process had taken place in those elements and that they had enough capacity to withstand the loads transferred by the new deck. Because of that and to ensure an increased durability, only reparation of the external surface was found necessary. Nevertheless, to increase the service life of the piers a reinforced concrete cover 15 cm thick was provided along the whole height of the external surface of all the piers (Figure 47). Additionally new bearings and joints were installed since the old ones had arrived the end of their service life. The reparation of the piers and the concrete cover were conducted before installation of beams for the new deck. The definitive bearings were installed during deck construction according to the construction process.

Figure 47. Rehabilitation of piers before deck construction

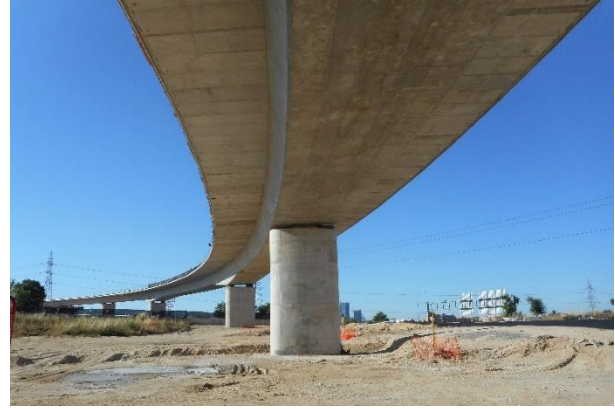
The result is a bridge with a new deck fully consistent with the current standards increasing the service life of the bridge more than a hundred of years (Figure 48). Of course, one of the problems is to keep, as much as possible, the service conditions of the road link, in this case, allowing traffic flow during all the construction process, which has as consequence the optimization of methods to increase productivity and to reduce the total construction period.

Figure 48. View of the bridge after completion
