# Barrier Replacement Works of the Ruitelán Viaduct A-6 P.K. 424 + 000

## *Obras de sustitución de pretil del viaducto de Ruitelán A-6 P.K. 424+000*

Jorge Alberto Cerezo Macías<sup>a</sup>, Elena Seguido Fernández-Tresguerres<sup>b</sup>

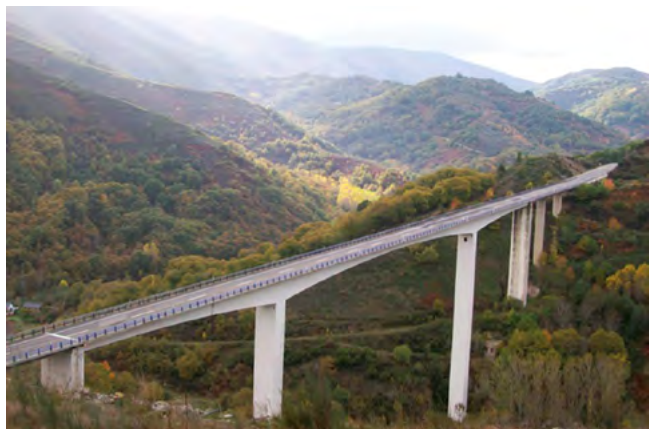
Figure 1. General view once the parapet has been replaced.

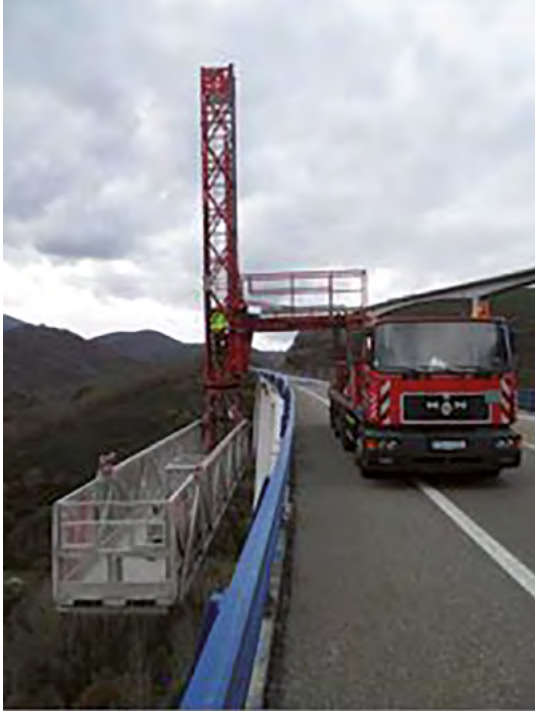
Figure 3. Walkway used in detail inspection.

The carried-out inspections included the use of auxiliary means, such as an articulated walkway on a truck, which allows access to the lower part of the deck, as well as checking the status of bearings at the top of the piers (figure 3).

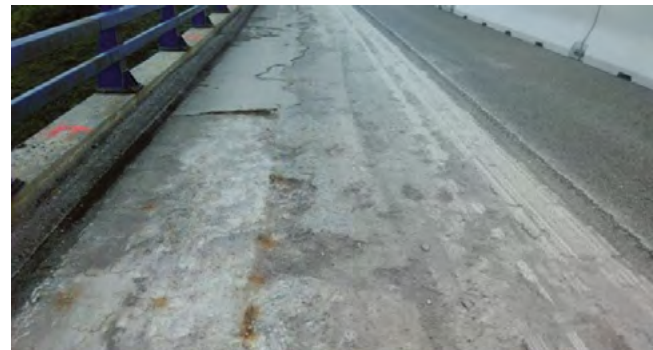
Figure 18. Milling the pavement.

The milling works, as is usual in this type of intervention, affected a slightly greater thickness than the theoretical one, due to the appearance of existing re-pavement layers.

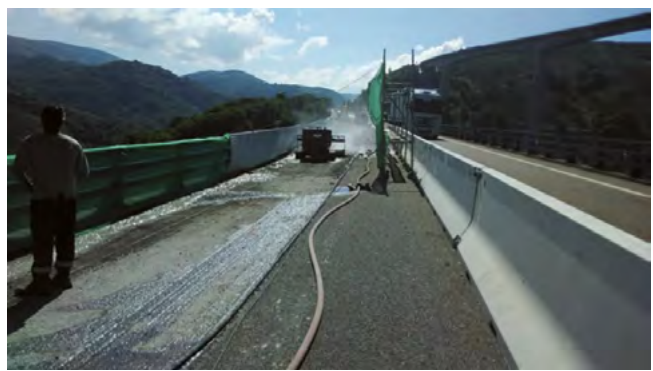
Figure 19. Partial hydrodemolition of the deck.

Next, the hydrodemolition (figure 19) of the upper face of the deck was carried out in a lateral strip of different thickness and width, depending on the area of the deck (spans 1 - 3, 4 - 6 or 7 - 9), as already mentioned (preserving the extreme fixing band of the current parapet).

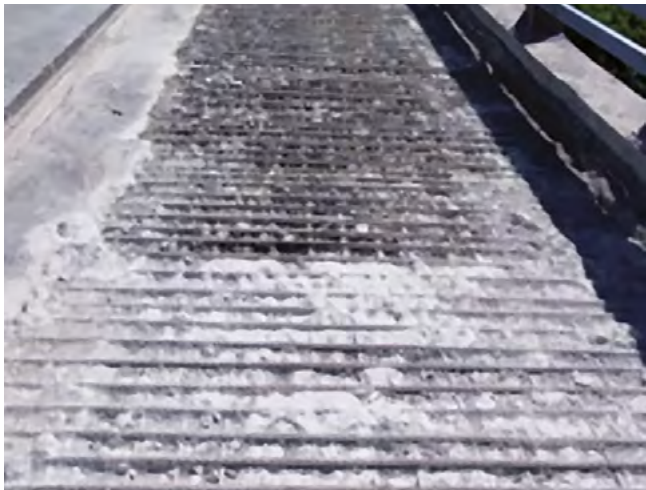
This hydrodemolition system left the reinforcement of the upper face visible, without deteriorating them, so that the new reinforcement required by the CE marked parapet could be overlapped with them (figure 22).

Figure 22. Existing reinforcement exposed.

It is worth noting that, when the existing reinforcement was discovered by the hydrodemolition, several situations different from those foreseen were found, either with separations between bars different from those theoretically known, as well as some areas with reinforcement of different diameters.

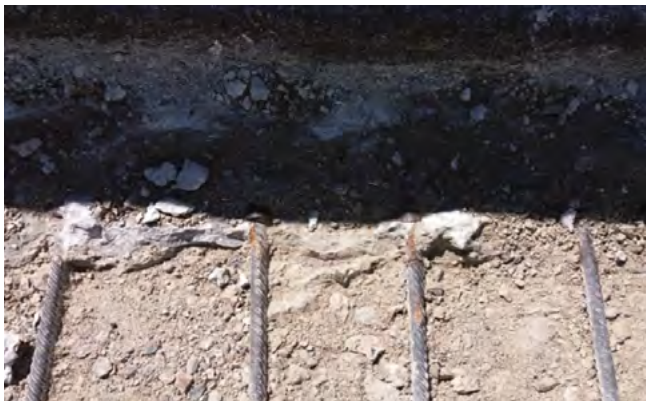
Figure 23. Detail of mechanical couplers.

The couplers used to overlap the reinforcements used in the panel expansion work carried out in 2002, were also exposed (figure 23).

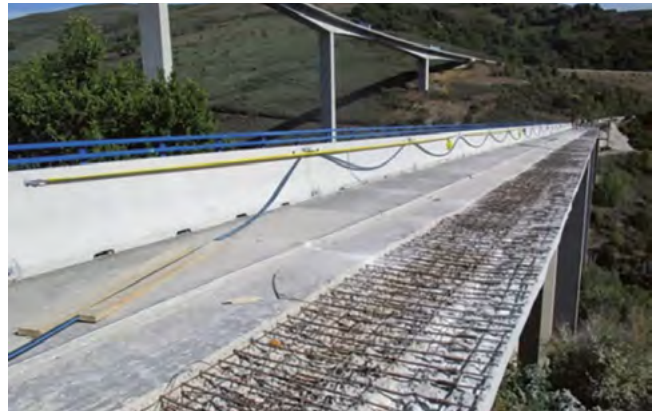
Figure 30. View after radial cutting of the strap

On the side face of the edge of the cut deck (figure 30 and figure 31) some holes were made to anchor the corresponding bars to the lower face of the reconstructed deck using epoxy resin.

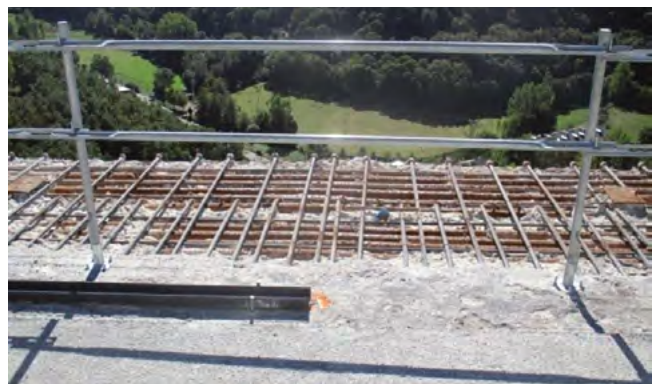
Figure 31. Detail of the radial cut of the strap.

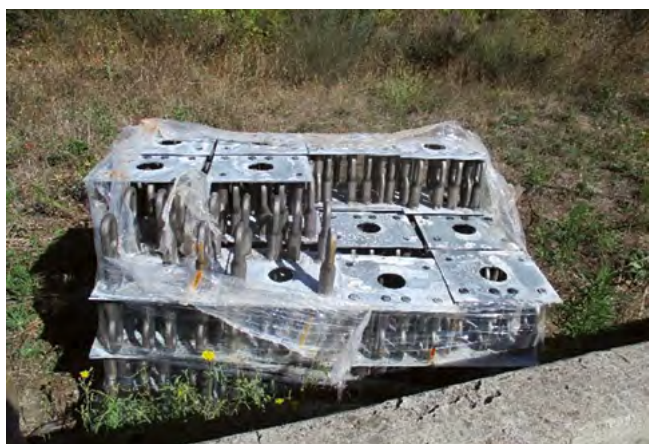
Figure 35. Anchorage of the parapet.

Subsequently, the band reinforcement was assembled, together with the plates and anchorages of the parapet uprights (figure 35), and the reinforcement of the upper face of the slab.

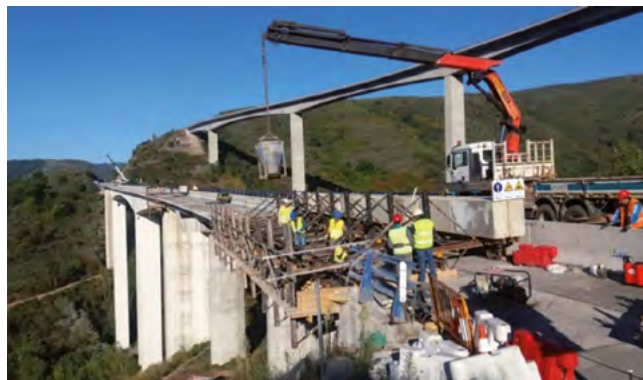
Figure 37. View of the concreting process of the deck and the strap.

Once the reinforcement and the anchorages were in place, the concrete was poured as a whole for the band and the deck (figure 37).

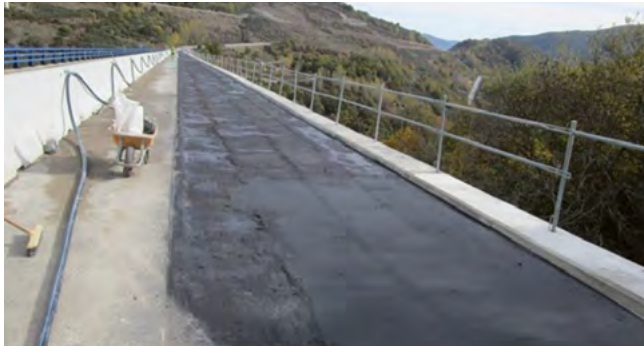
Figure 39. Rebuilt waterproof deck view.

Next, it was carried out the waterproofing of the reconstructed deck area (figure 39). For this purpose, an adhesion irrigation was applied under the wearing course, consisting of a modified cationic emulsion (C60BP3 ADH) with a dosage of 8 kg/m<sup>2</sup>, completed with a waterproofing treatment consisting of an anionic bitumen emulsion (COMPOPRIMER) with 0.3 kg/m<sup>2</sup> and a bituminous mortar (AMIFLEX) with a dosage of 3 to 4 kg/m<sup>2</sup>.

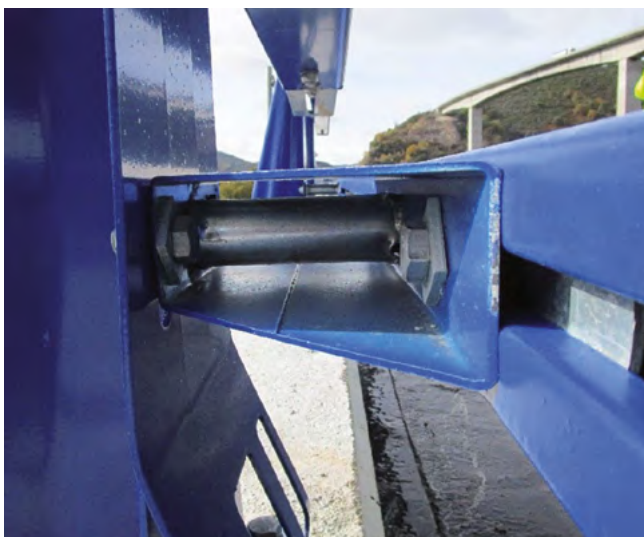
Figure 41. Detail of fixing of the new installed parapet.

The parapet is fixed by nuts to the screws (which act like a fuse in case of impact) in the anchor plate embedded in the band (figure 41).

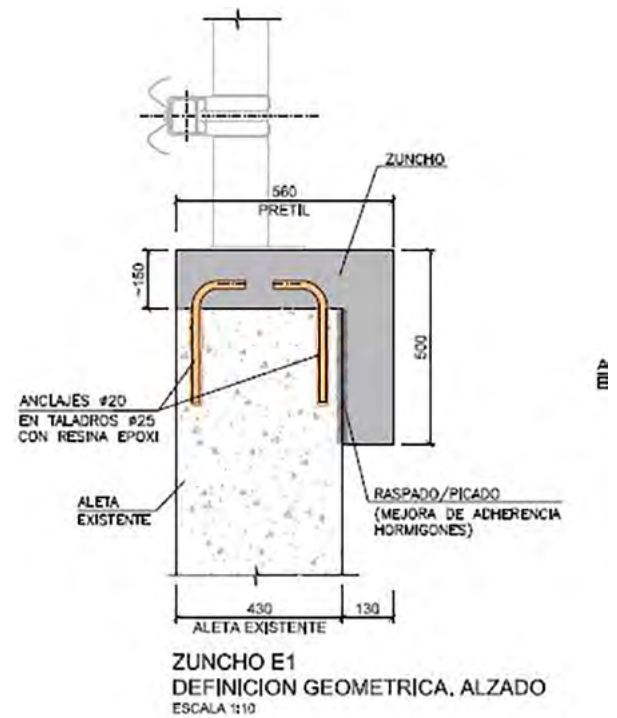
Figure 42. Strap in Abutments.

Finally, some bands were executed for the embedding of the parapet in the wing walls of both abutments, finishing off the containment system at both ends (figure 42).

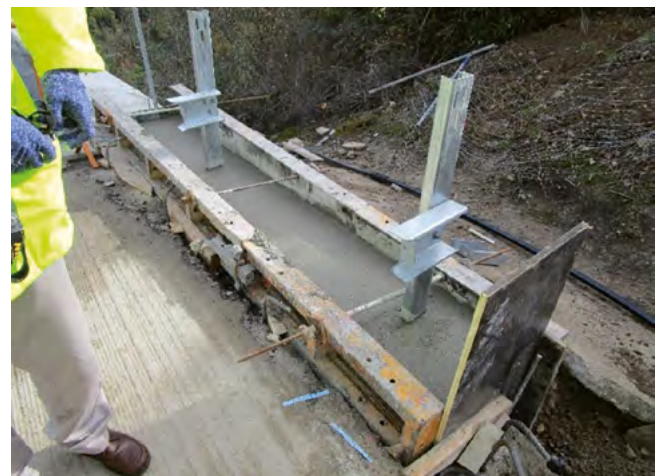
Figure 43. Concrete straps in the abutment area.

For this purpose, the anchoring of the parapet in the area was solved in both abutments by embedded bands with pins anchored to the existing wing wall of the parapet itself, in order to generate an area with the needed geometric dimensions and the required assembly for the fixing of the parapet (figure 43).

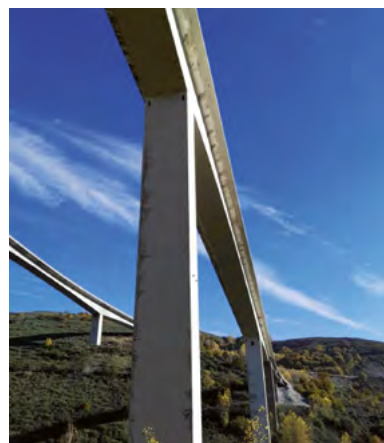
Figure 46. Bottom view of rebuilt deck.

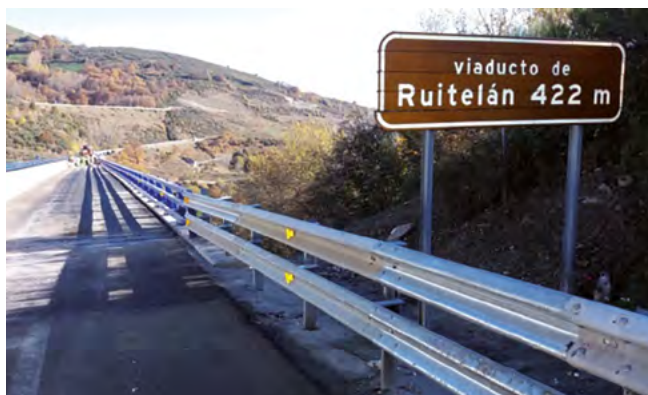
Figure 47. View from Galicia Side Abutment.
