Progreso's viaduct in Yucatan, Mexico: First durable concrete structure in the world made with stainless steel

Andrés A. Torres-Acosta^{a,*}, Miguel Martínez-Madrid^b, Pedro Castro-Borges^c

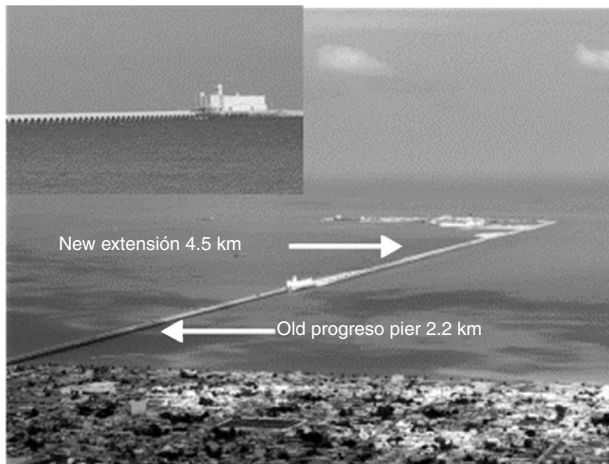
During the 1980s, the Mexican federal government initiated the construction of a Remote Terminal, to which the old Progreso pier was joined by a 4-lane viaduct. The Progreso pier, whose original viaduct length was 2.2 km, now has an additional 4.5 km. Fig. 2 shows the whole pier extension. This addition transformed the Progreso port to a deep port, which can allow 10-m deep ships to dock.

Figure 2. Aerial photograph of the old pier and the extension built in the 80s.

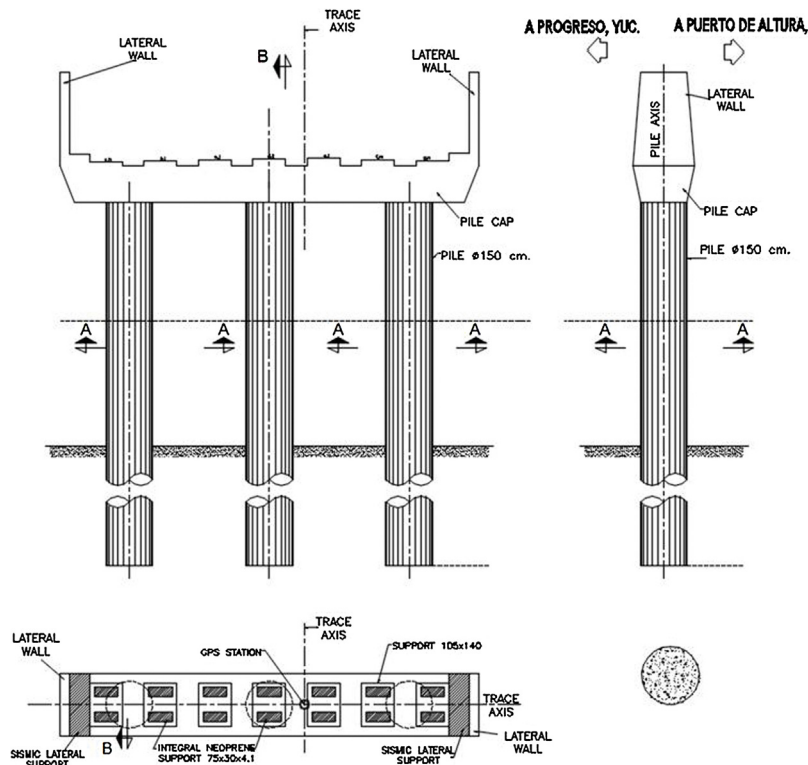
Figure 6. Substructure detail of the Progreso’s new viaduct.

to get a durable structure with little maintenance (mainly routinely, i.e. bearings, deck surface, deck joints, painting metallic elements, parapets, trenches). The substructure consists of three reinforced concrete pylons (1.5 m diameter, 10 cm concrete cover) and one reinforced pile cap (1.20 × 1.50 m, 7 cm concrete cover), as presented in Figs. 6 and 7.

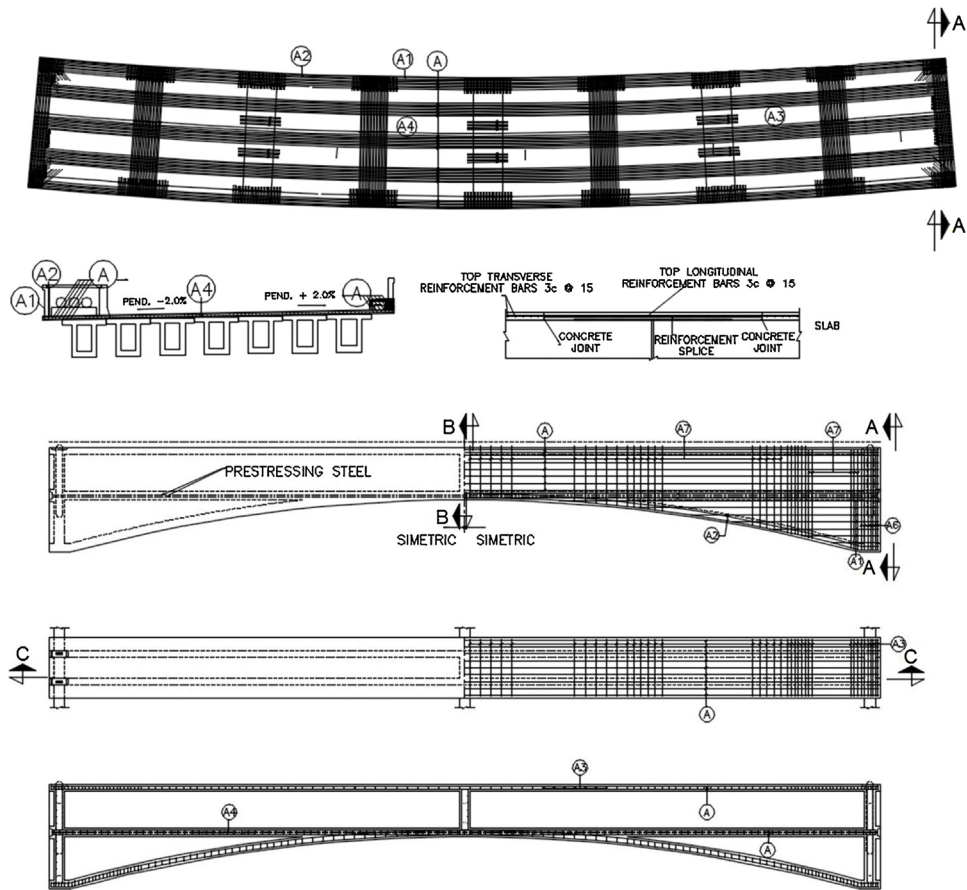
Figure 7. Superstructure details of the Progreso's new viaduct: above deck, below prestressed arched beam.

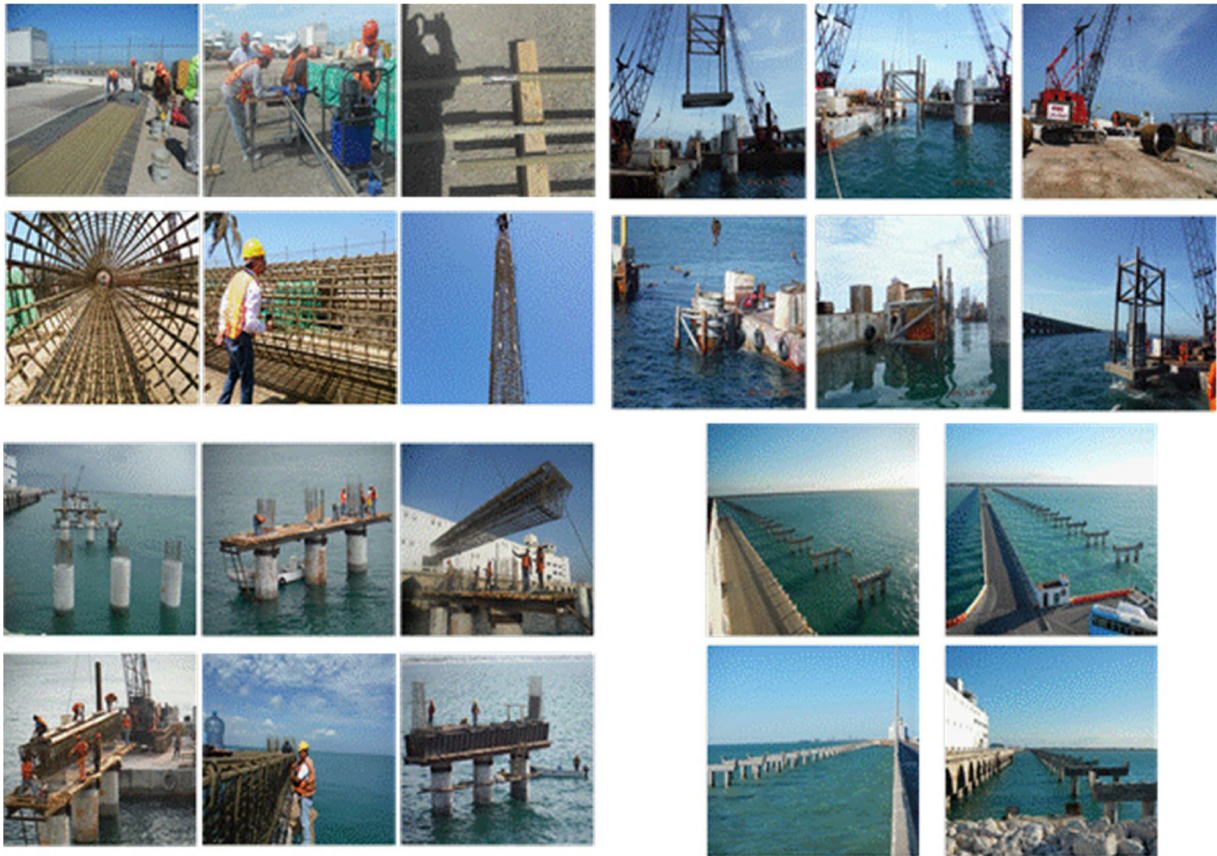
Construction started in February 2014, and ended in May 2017. Fig. 8 shows some aspects of the construction of Progreso's new viaduct. More details of the construction processes will be published in the near future. The works are programed to end in May next year, but everybody knows that construction works normally ends few weeks later, or even months due to none programed activities or contract extensions.

Figure 8. Construction process photographs: substructure construction stage.
